# Manhole Inspection Summary

Manhole # S21C1\_021MH

Insp Date: **5/21/08 12:14 PM**

**Location** Address: **2627 paca st**

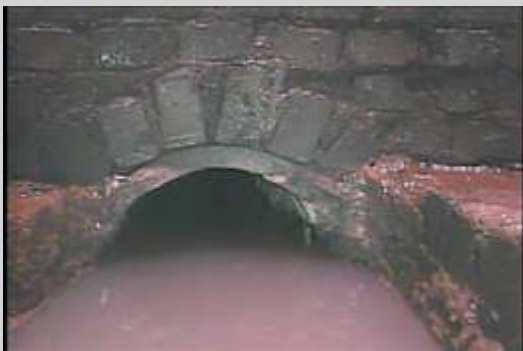
3 O'Clock Inflow

15 in. Circular Gravity Sewer  
Pipe In @ 3 O'Clock

Pipe Height: **15.6** (in.) Rod and Bar (Angled)  
Pipe Material: **Clay** ☐ Pipe Lined  
Invert Depth: **16.11** (ft.) Flow Characteristics: **Fast**  
Deposits: ☒ **None** ☐ Mud ☐ Sludge ☐ Debris ☐ Grease  
Silt Depth: **0** (in.) Deposits Extent:  
Infiltration: **None** Pipe Seal Cond: **Sound**
